Improved Concrete Cutting and Excavation Capabilities for Crater Repair

Phase 1

Final report

Prepared for Headquarters, Air Force Civil Engineer Center
Tyndall Air Force Base, FL 32403-5319

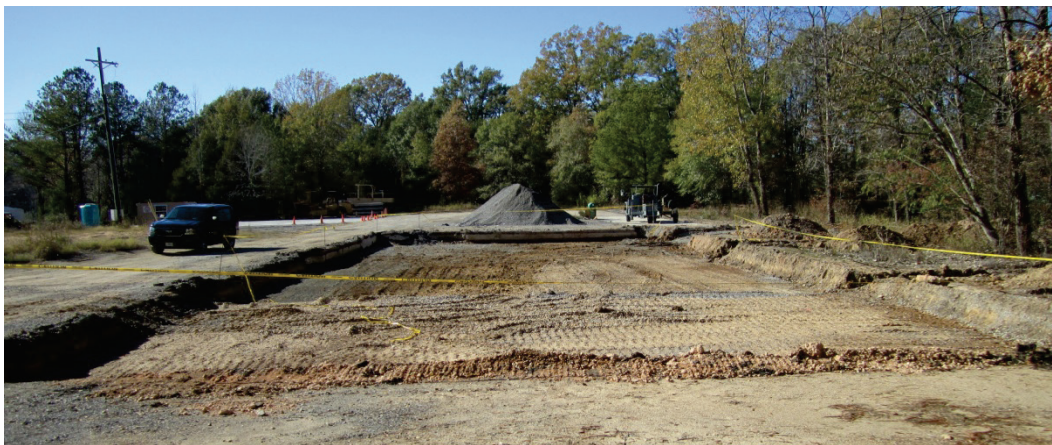
The site for the test section was cleared of existing vegetation and a previous test section constructed on the site was removed (Figure 2). The existing subgrade was leveled prior to construction with a 0.8 percent grade in the profile (east to west) and 0.3 percent grade south to north to allow for drainage. A drainage ditch was also constructed off the side of the center of

the section (depicted in the far right, center of Figure 2). For both the HMA and PCC sections, 6 in. of crushed limestone was used as the base layer, and clay gravel was used for the subbase of the 18-in.-PCC and the HMA section. The existing subgrade served as the subbase of the 24-in.-thick PCC section. Each layer was compacted to a target of 95 percent modified Proctor density or to the point that in-place density did not increase with additional compactive effort. A Caterpillar CS433E vibratory smooth drum roller and a Wacker WP 1550 W plate compactor were used for compaction (Figure 3).

Figure 2. Excavation for test site construction preparation.

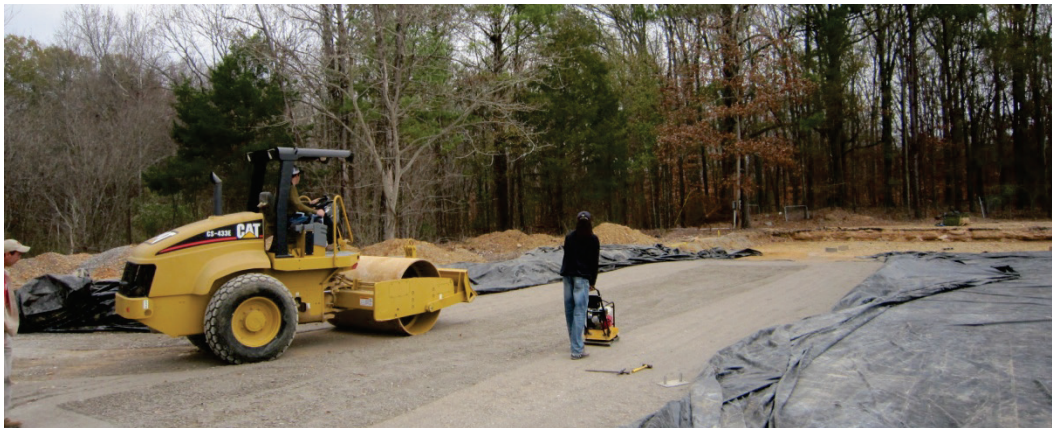
Figure 3. Compaction of base using a vibratory smooth drum roller and plate compactor.

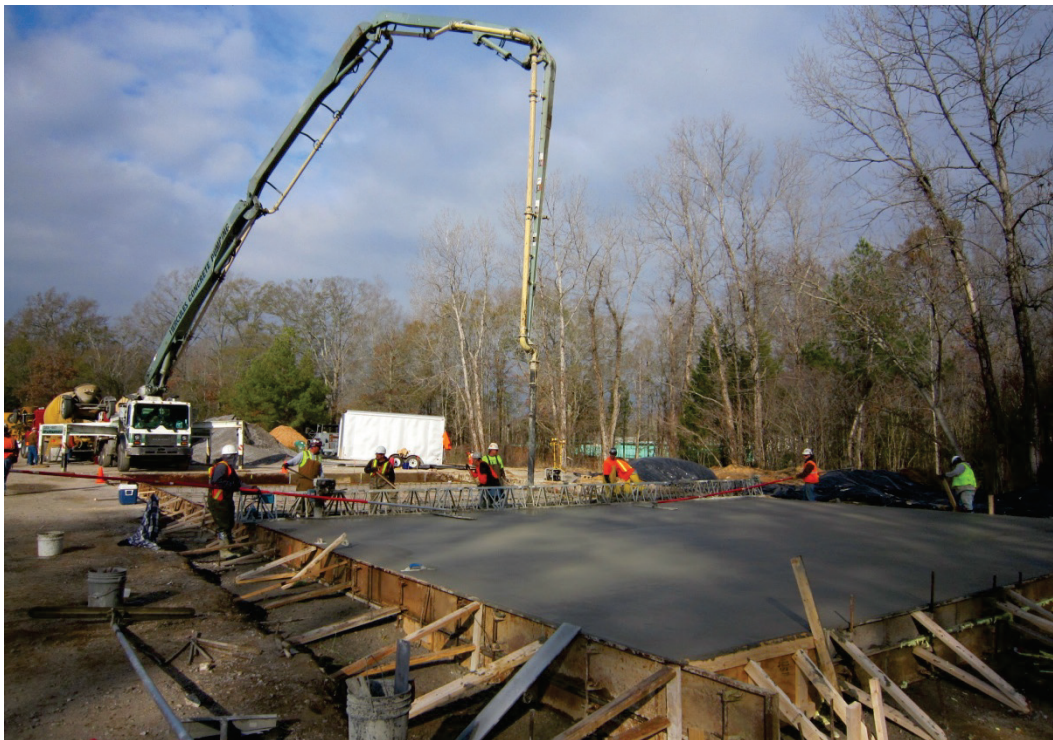
Figure 5. PCC placement.

PCC construction work was completed by Dark Horse Construction, LLC from DeSoto, MO. The PCC mixture was produced using a local Federal Aviation Administration (FAA) mix design used at the Jackson-Evers International Airport, MS. The mix was a 650 psi flexural strength (4,000+ unconfined compressive strength (UCS)) mixture using limestone (Figure A4). During placement, test specimens were prepared in accordance with ASTM C39 (2010) for compressive cylinders and ASTM C78 (2010) for flexural beams. Laboratory data for this mixture are included in Table 7. The PCC was placed using a pump truck (Figure 5), consolidated with 2-in. spud vibrators, and screeded with a self-powered, vibratory truss screed. A maximum slump of 7 ± 1 in. was specified, and concrete trucks delivering batches that did not meet the specification were rejected. Fresh property data were taken periodically, with the average slump measuring 7.8 in. and the average air content measuring 5.8 percent. The PCC section was completed with a light broom finish, coated with a curing compound, and then saw-cut to provide transverse and longitudinal joints. The joints were saw-cut approximately 17 hr after the concrete placement. The 18-in.-thick section was saw-cut to a depth of 5 in., and the 24-in.-thick section was saw-cut to a depth of 6.5 in. A white-pigmented curing compound meeting the ASTM C309-11 (2011) specifications was used.

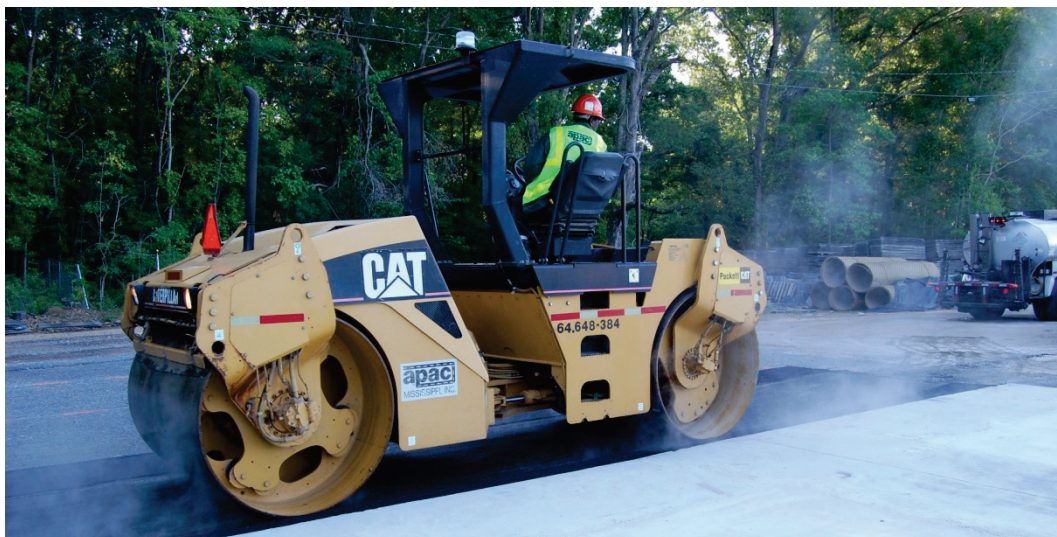
Compaction between lifts was completed with a Caterpillar CB-534D double drum roller (Figure 6), Ingersoll Rand PT-125R pneumatic roller, and Ingersoll Rand DD-28HF vibratory double drum compactor (Figure 7). Density was measured with the Troxler nuclear moisture-density gauge and was determined to be adequate for the purposes of this test. The laboratory mix properties were out of specification limits resulting in a tender mix and some movement of the material during compaction (Table 8 and Table 9). The base course was uneven and had some poorly compacted or wet areas resulting in some movement of material during compaction and some unevenness of the final surface. Two nuclear gauge readings were taken with a Troxler 3440 in each location and averaged (Table 10), and cores (Table 11) were taken in areas where the base was firmly compacted. The data indicated that sufficient compaction was achieved. In-place density should be 92-95 percent of the theoretical maximum density (TMD). Final thickness of the compacted mat was on the order of 5 in. with one area being slightly thinner on the order of 4.5 in. thick. The condition of the HMA test section did not affect the research.

Figure 6. HMA compaction with a double drum vibratory compactor.

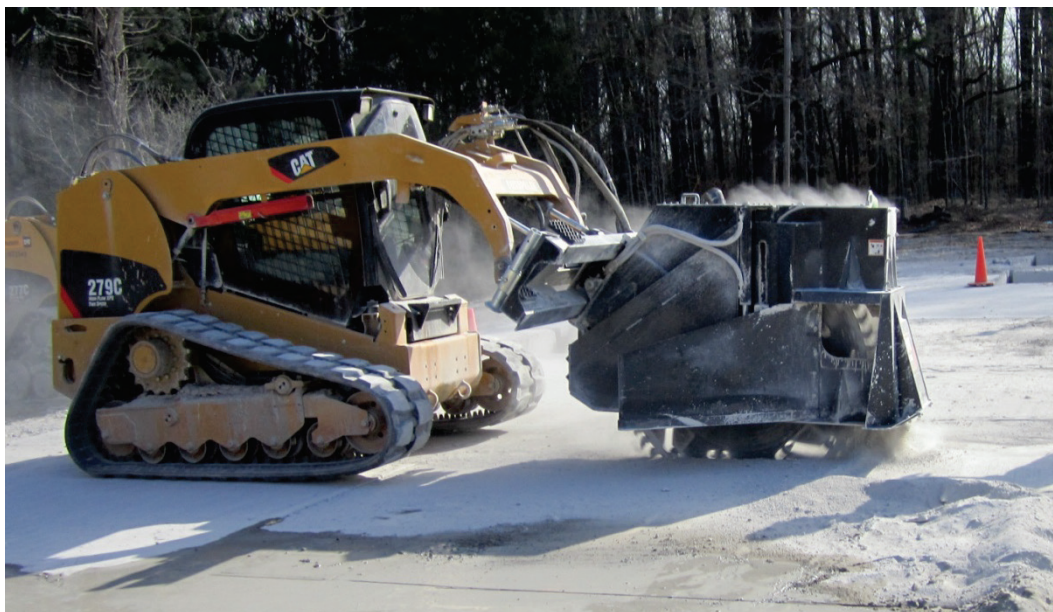
Caterpillar 279C compact track loaders (CTL), or skid steers, are high-flow, rubber-tracked machines with quick disconnect fittings that are used extensively in the current ADR TTPs (Figure 8). The quick disconnect allows attachments to be switched out rapidly without the use of tools. The multi-purpose machines are employed for many of the ADR processes including rapidly cutting around the upheaval of bomb-damaged pavement using wheel saw attachments, breaking pavement using the hammer attachment (Figure 9), removing debris using bucket attachments, screeding pelletized asphalt caps with the asphalt screed attachment, or cleanup with the broom attachments. Specifications for the machine and hammer can be found in Table 12 and Table 13, respectively.

Figure 8. Caterpillar CTL279C, operating a SW45 wheel saw attachment.

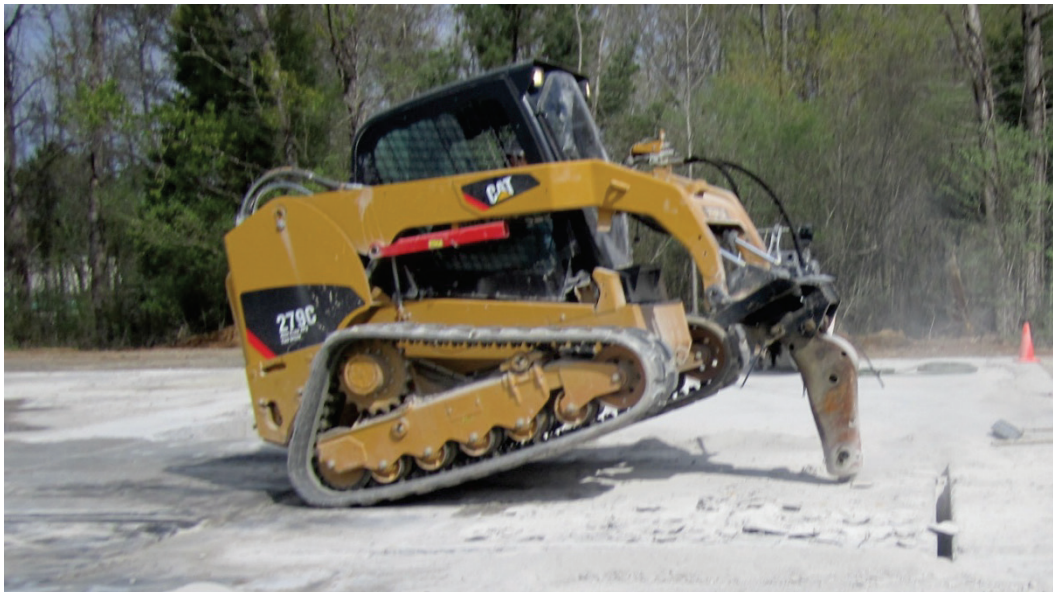
Figure 9. Caterpillar CTL279C with the H65D S hammer attachment.

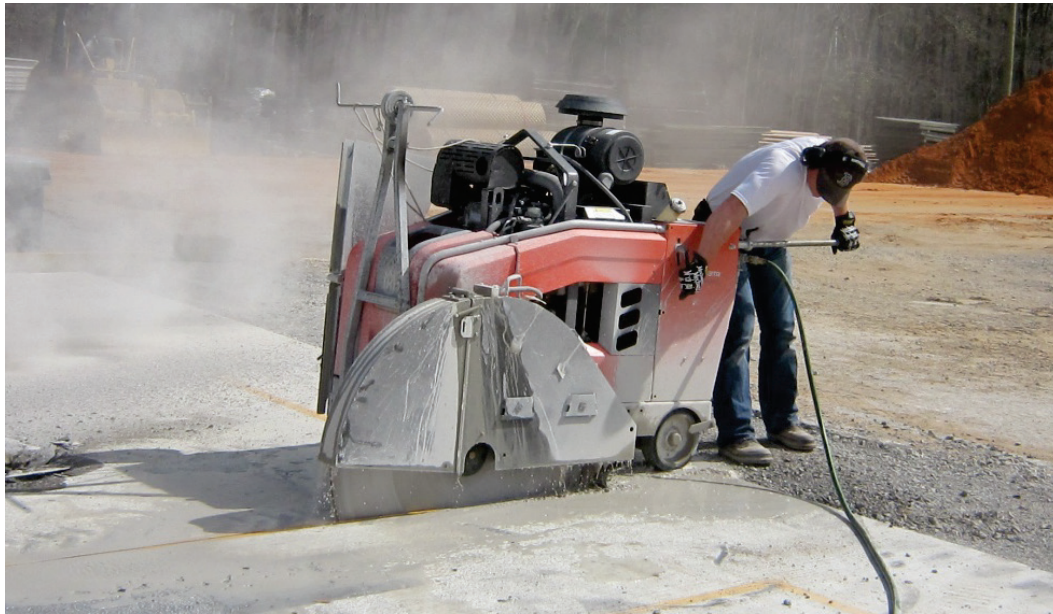
The Husqvarna FS 6600D (Figure 12) is employed in the ADR TTPs when dowels are encountered in the removal of damaged pavement. The self-propelled walk-behind wheel saw is equipped with a 42-in.-diam diamond blade. The Husqvarna saw is propelled by a John Deere motor with 66 hp

and weighs 1,892 lb. The maximum cutting depth is 17.5 in. using a 42-in.-diam diamond-tipped blade. An external water supply is required to cool the blade while the saw is in operation.

Figure 12. Husqvarna FS 6600D.

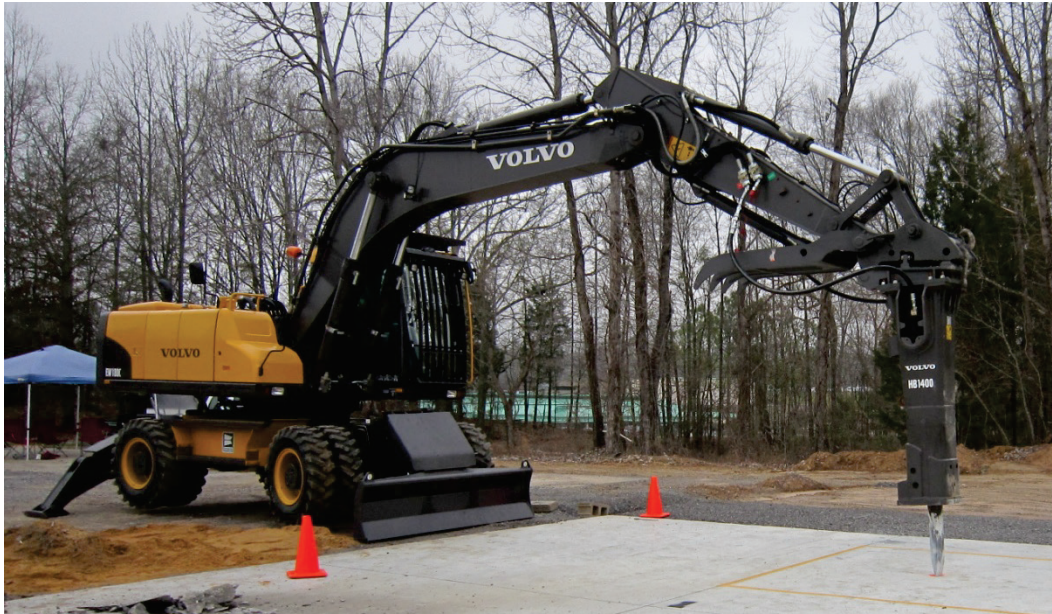
A Volvo EW180D wheeled excavator (Figure 13) is used in the ADR TTPs to break the PCC and excavate the broken PCC and underlying material. Wheeled excavators are preferred to tracked excavators for crater repair purposes because they minimize damage to the existing pavement around the repairs. The excavator is equipped with quick-disconnect fittings for the hammer and bucket work tool attachments. Table 15 presents the specifications of the Volvo EW180D wheeled excavator.

The concrete was broken using a Volvo HB1400 hammer (Figure 13) with a chisel point and amoil point. Two different sized toothed buckets, 24- and 36-in.-wide, were used for removing disturbed material (Figure 14). The teeth on the 24- and 36-in.-wide buckets were 9.5 and 7.75 in. long, respectively. The excavator was equipped with quick-disconnect fittings for the hammer and bucket work tool attachments. Specifications for the Volvo HB1400 hammer are listed in Table 16.

Figure 13. Volvo EW180D excavator with Volvo HB1400 hammer.

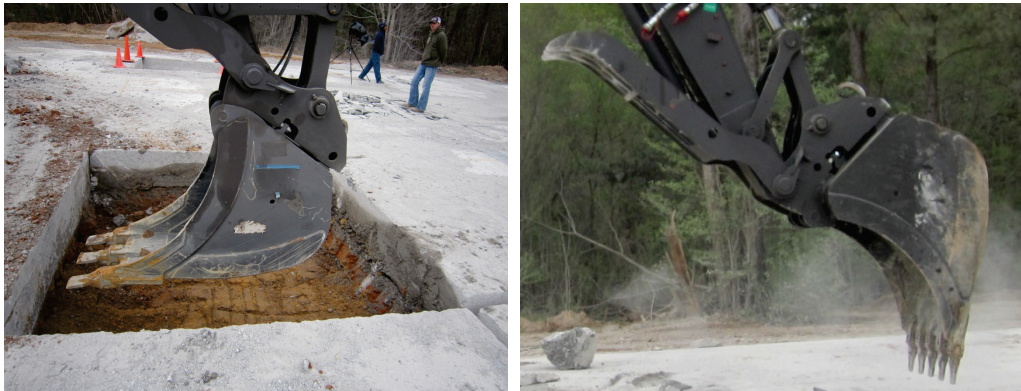
Figure 14. Excavator 24-in.-wide bucket (left) and 36-in.-wide bucket (right).

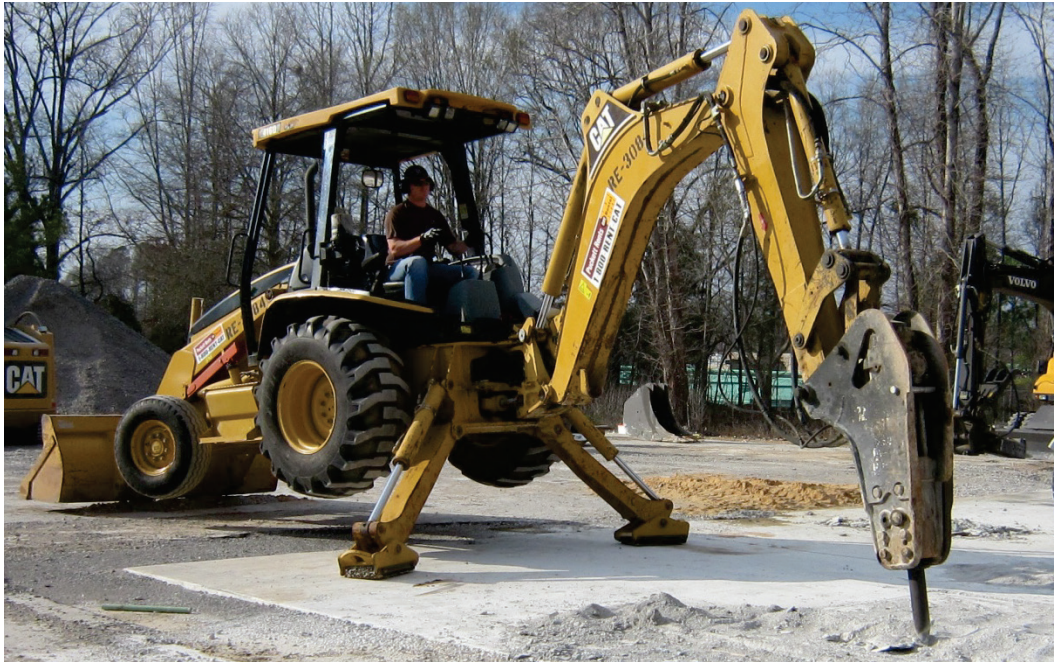
Figure 15. Caterpillar 416D backhoe withmoil point hammer.

A Caterpillar 416D backhoe with a moil point Caterpillar H90 hammer (Figure 15, Table 17) was evaluated in the current study for its ability to break up the concrete during the excavation process. The Caterpillar 430D backhoe was equipped with a 24-in.-wide rotating bucket capable of turning 180 deg (Figure 16). The teeth were 6.5 in. long on the rotating bucket. The efficiency of the rotating bucket was compared to a stationary bucket and repositioning of the backhoe.

Energy class	1,200 ft-lb
Operating weight	1,298 lb
Tool diameter	3.3 in.
Acceptable oil flow	16-39 gpm
Operating pressure	1,958 psi
Impact rate	500 -1,450 blows per min
Carrier weight limits	15,400 – 26,400 lb

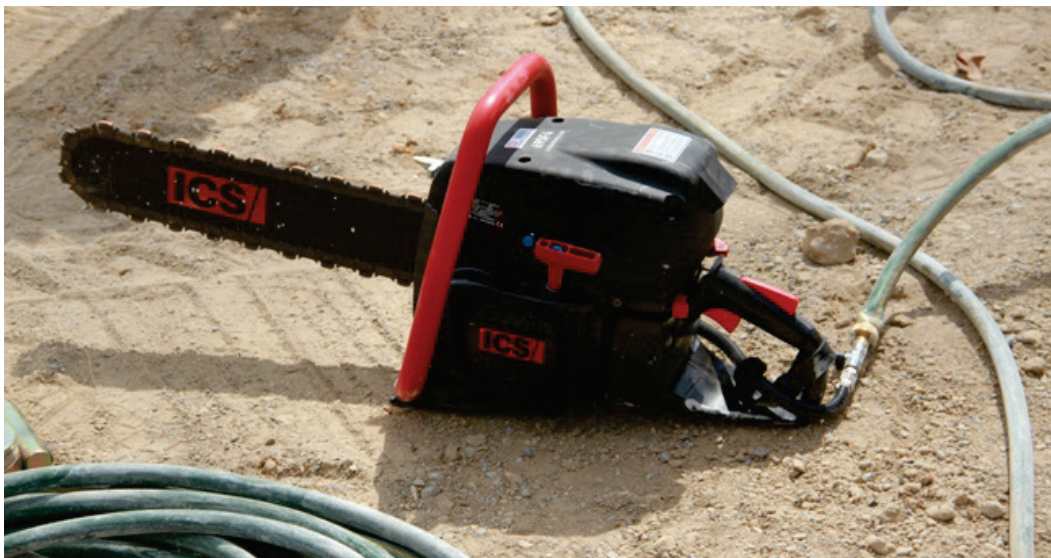
Figure 17. Concrete chain saw.

A 695F4 ICS utility chain saw, designed for concrete cutting, was evaluated as a supplemental tool to aid in the saw-cutting process (Figure 17). The concrete chain saw is equipped with a 16-in.-long bar with diamond chains and weighs approximately 21 lb. Gasoline and water are required to operate the saw. The utility chain saw is operated in the same manner as a standard chain saw.

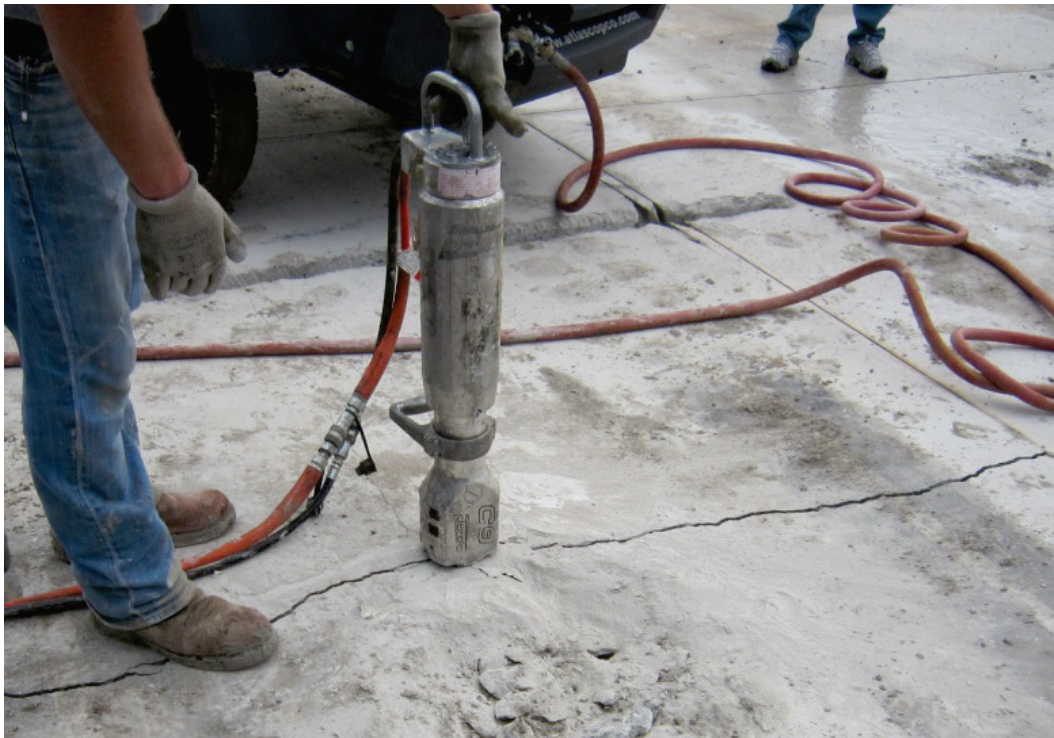
A Darda rock splitter (size 9) was evaluated in this study as an alternative and/or supplement to breaking the PCC using an excavator hammer. The rock splitter is capable of breaking the PCC into smaller pieces for easier removal. The technology requires a 49-hp compressor, drill, drill bits, fuel, paste, and a generator. To effectively crack the concrete, a 1.75-in.-diam drill bit is required to drill a hole 18 in. deep. The rock splitter's wedge set is inserted into the predrilled hole. Paste is used on the wedge set of the rock splitter for ease of inserting and removing in the drilled holes. Using

Figure 18. Darda rock splitter.

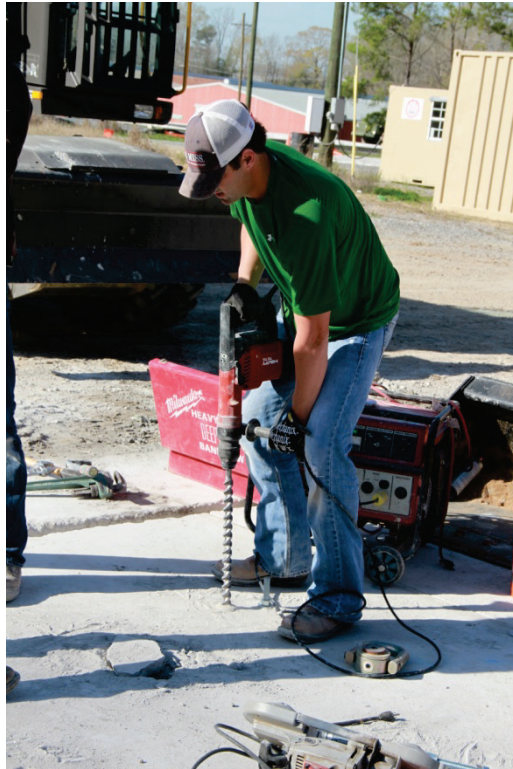
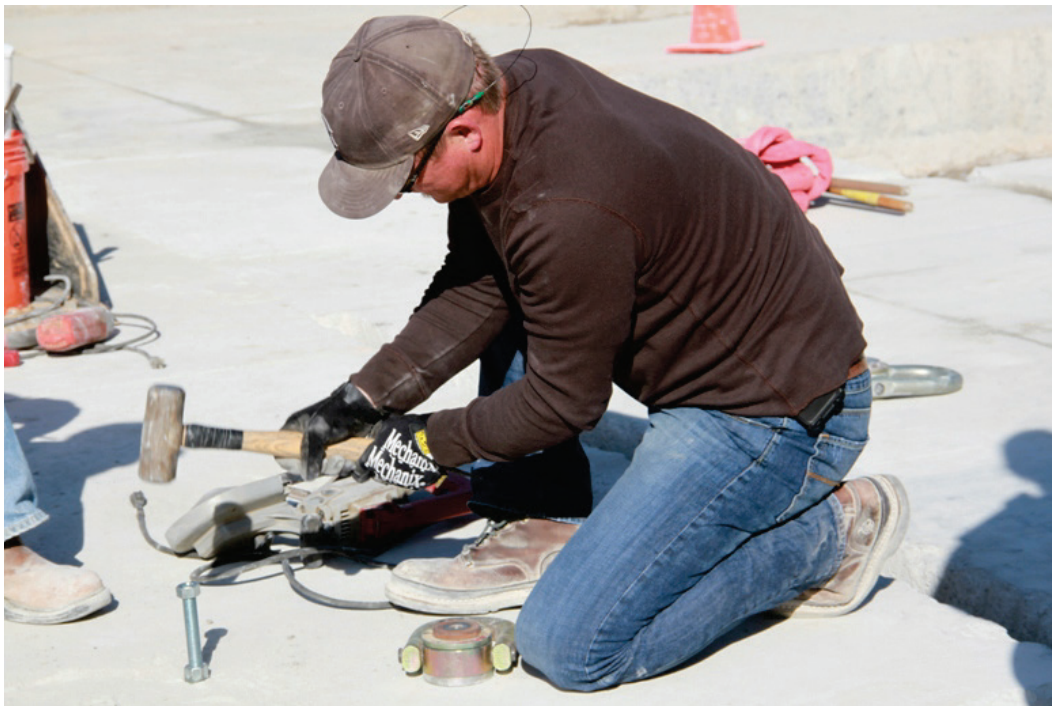
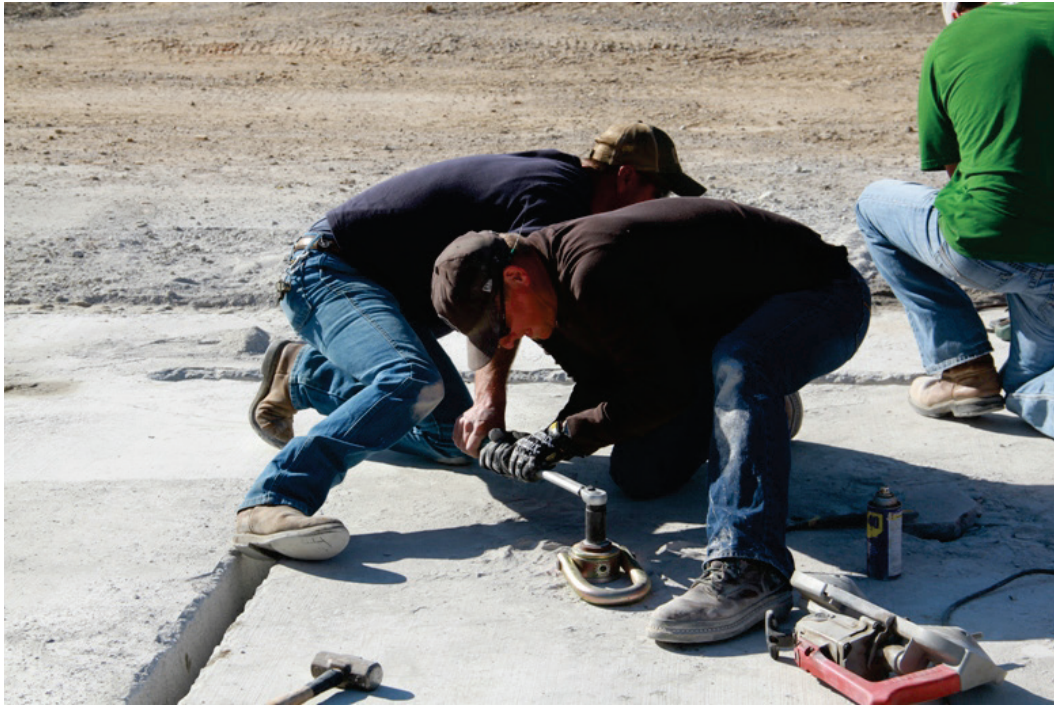
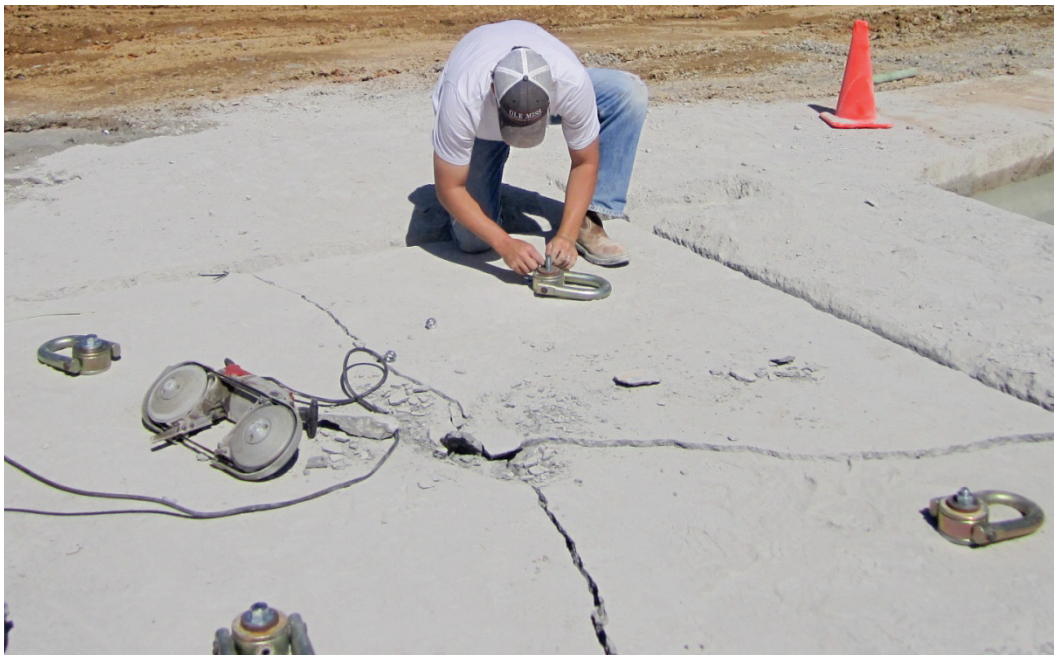
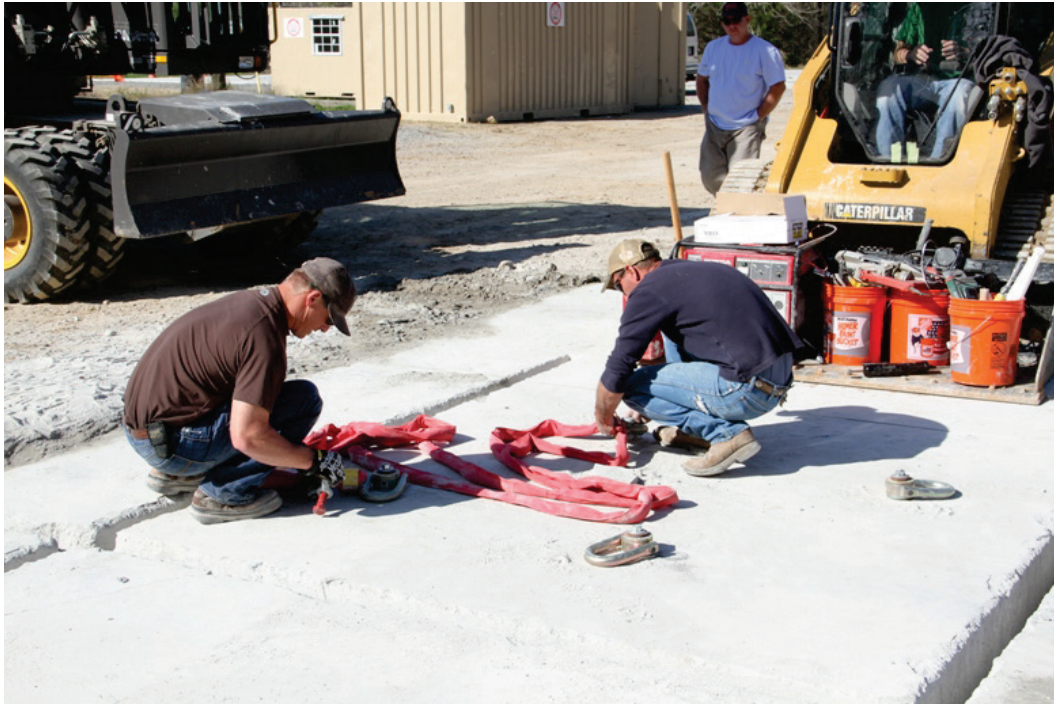
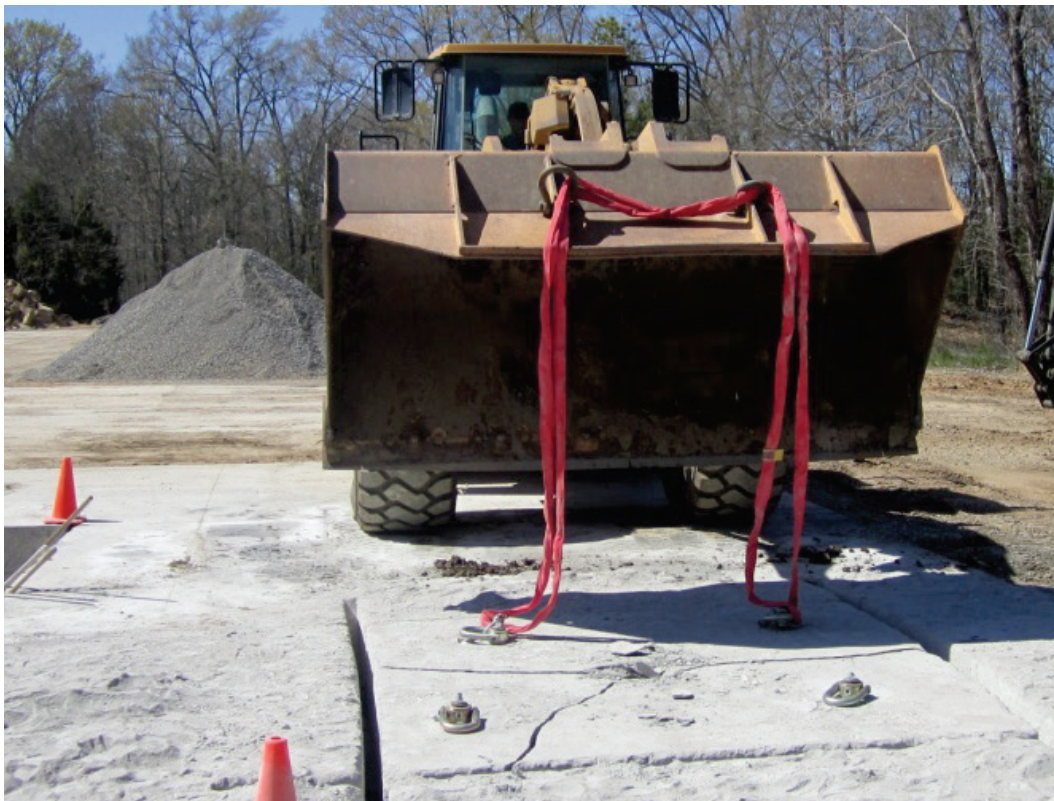
An anchor pullout system using concrete expansion anchors was evaluated in this study for its ability to excavate the thick concrete. The anchor pullout system process involved drilling two 1.25-in.-diam holes (12-in.-maximum depth) into the PCC (Figure 19), cleaning the hole with compressed air, installing the concrete expansion anchors (Simpson's Torq-Cut™ TCAP751458) in the drilled holes (Figure 20), cutting off excess threaded rod using a band saw, attaching the lifting hoists to the anchors with a torque wrench (Figure 21 and Figure 22), attaching the shackles to the endless round slings (Figure 23), and attaching the slings or a chain to a piece of powerful equipment such as a front-end loader (Figure 24), excavator, or forklift (CAT TL1055). Using the anchor pullout system requires that the pavement be saw-cut full-depth before removal. This anchor pullout system is used for removal of slabs prior to placement of precast panels for airfield pavement repairs (Bly et al. 2013).

Figure 19. Drilling hole for anchors.

Figure 20. Driving concrete expansion anchor into drilled PCC.

Figure 21. Tightening anchors with torque wrench.

Figure 22. Finishing up with the lifting hoists and shackles.

Figure 23. Attaching straps to the shackles.

Figure 24. Straps attached to front-end loader, ready to remove the broken slab.

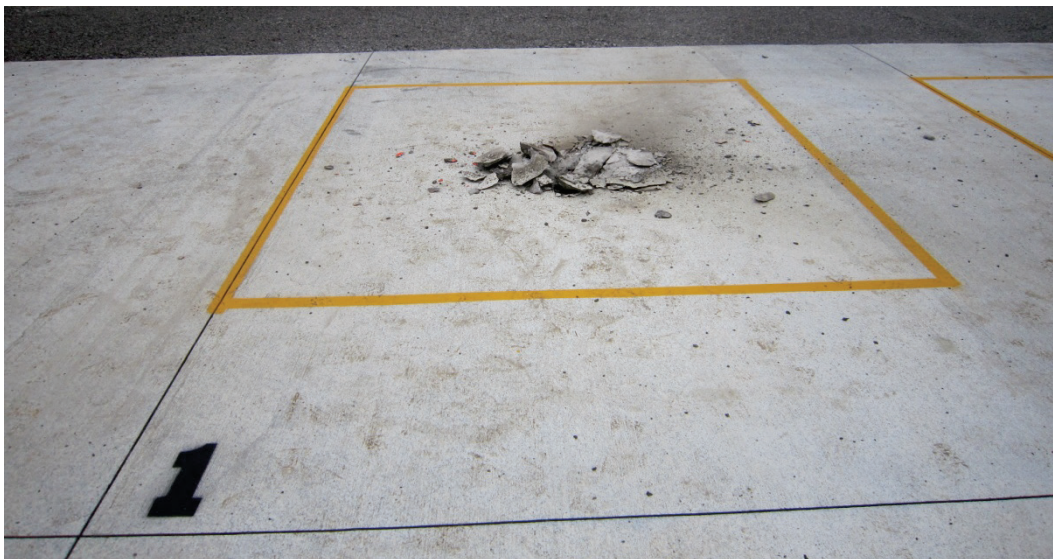
The saw and excavation crater repair technologies were evaluated in February and March 2012 for the PCC and June 2012 for the HMA. Craters were simulated using the excavator with the chisel point hammer. The simulated craters ranged in diameter from 2 to 4.5 ft. No upheaval was generated during testing. In a war time scenario, upheaval is expected. Figure 25 shows a simulated crater. An approximate 8.5- by 8.5-ft square was marked outside of the centered simulated craters as a guide for the saws to follow.

Figure 25. Simulated crater.

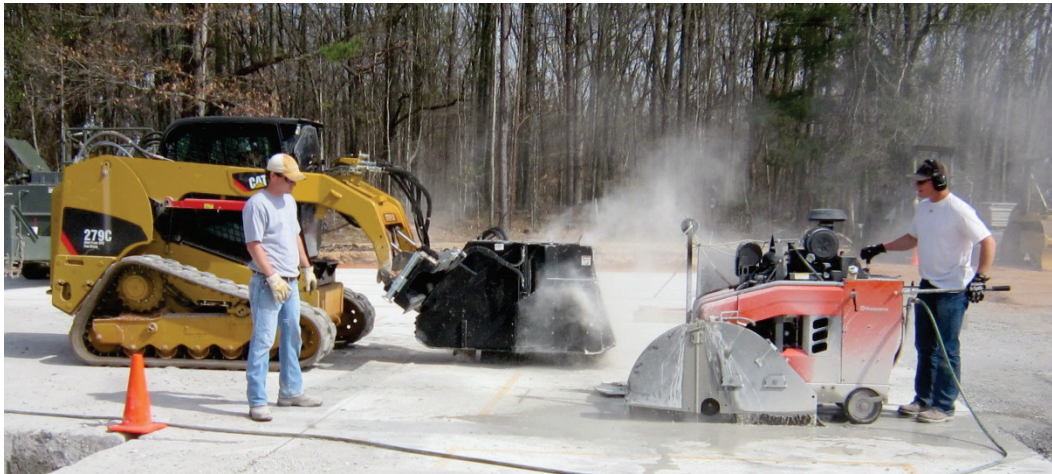
Figure 26. Walk-behind saw with wheel saw, operating simultaneously.

Three saws, the SW45 wheel saw, the SW60 wheel saw, and the Husqvarna walk-behind saw, were evaluated for their efficiency and maneuverability of cutting around small craters. The walk-behind saw was the only machine used to cut along the doweled joints and was normally used simultaneously with the wheel saws (Figure 26). The wheel saws attached to a CTL were mainly used to cut along the non-doweled repair edges. For the ADR modernization program, wheel saws are preferred over walk-behind saws, because they are easier to transport, require no water, and they make excavation easier because of the resulting wide cut width.

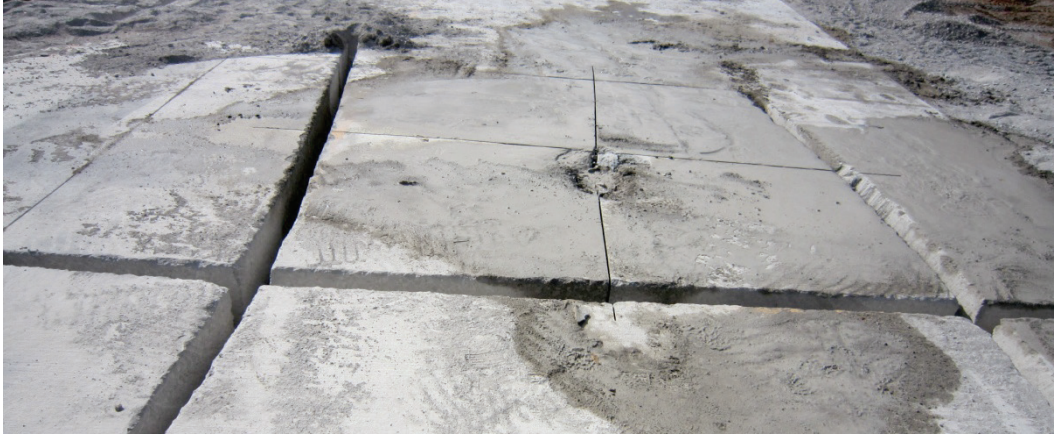
Relief cuts within the already sawed crater repair area were evaluated to determine if they increased the production rates of the excavation process. Relief cuts were explored in previous ADR demonstrations (LOUA2) for thick PCC (Priddy et. al. 2013a). Four craters received relief cuts, three using the SW45 wheel saw and one using the walk-behind saw, all in varying patterns. Three patterns were tested: a “t pattern” (Figure 27), “x pattern” (Figure 28), and combination of a center relief cut with a bucket-sized relief cut in the center (Figure 29).

Figure 27. Relief cuts on Crater 7 in a “t pattern,” dividing the crater into quadrants.

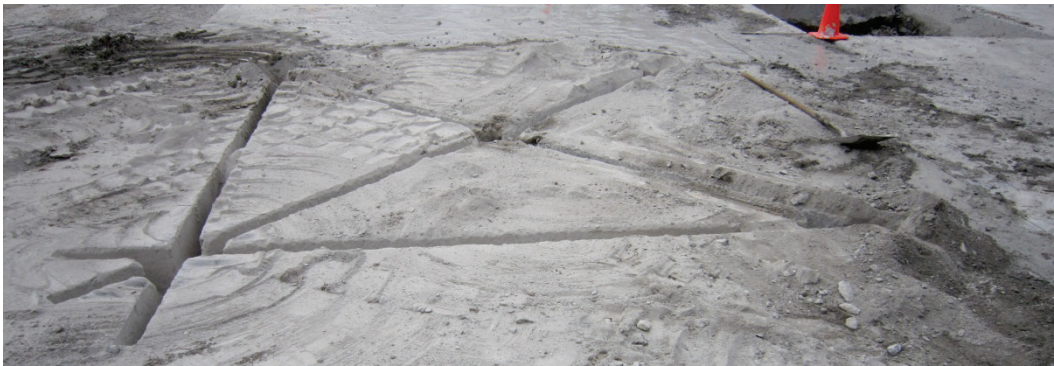
Figure 28. Relief cuts on Crater 9 in an “x pattern,” dividing the crater into quadrants.

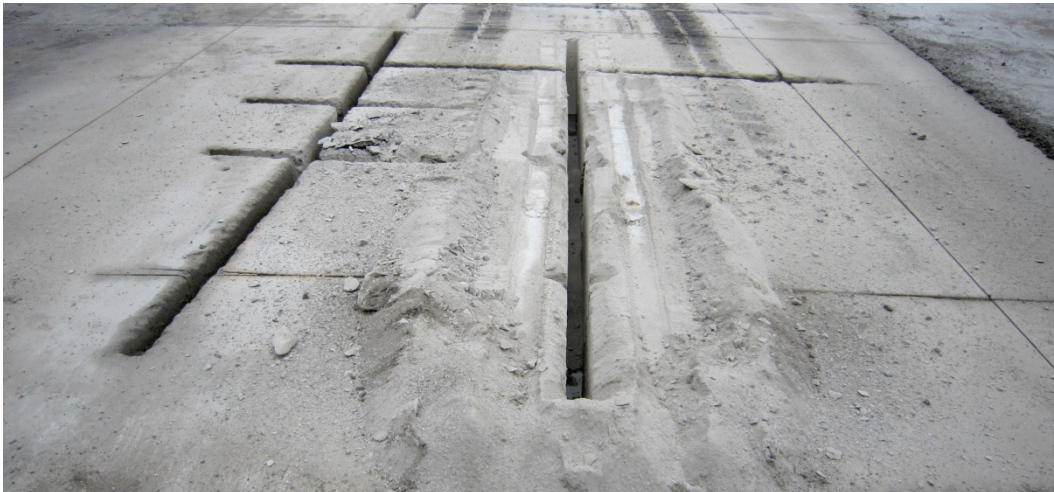
Figure 29. Combination of bucket size relief cuts and a center relief cut on Crater 13.

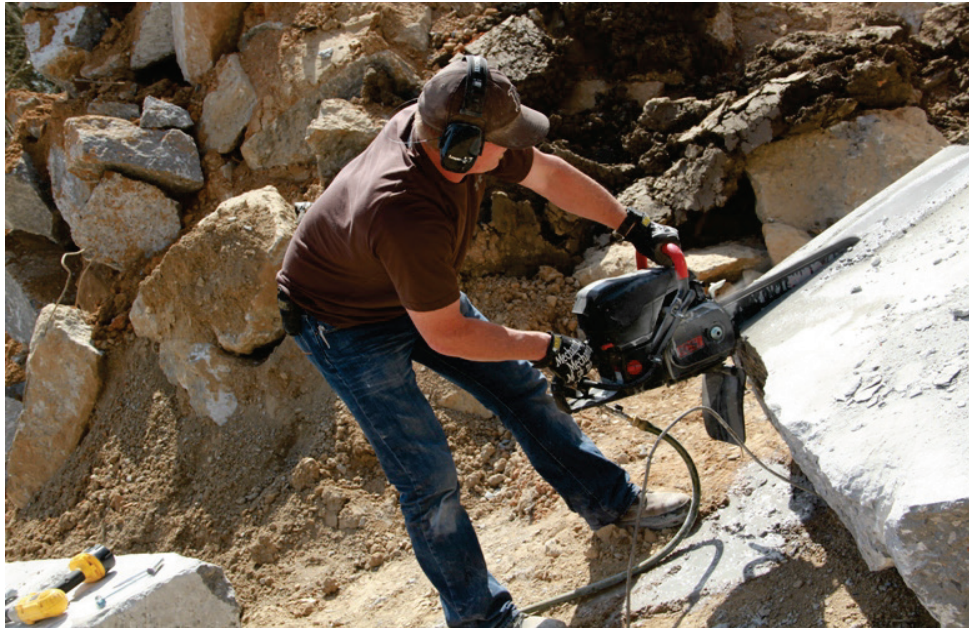
The concrete chain saw was not used in the test section, but it was evaluated as a supplemental technology by cutting through large broken pieces of PCC. The chain saw was tested for its production rate and its ability to saw through PCC and dowel rods. Figure 30 shows the chain saw cutting through the PCC.

Figure 30. Utility chain saw cutting through PCC.

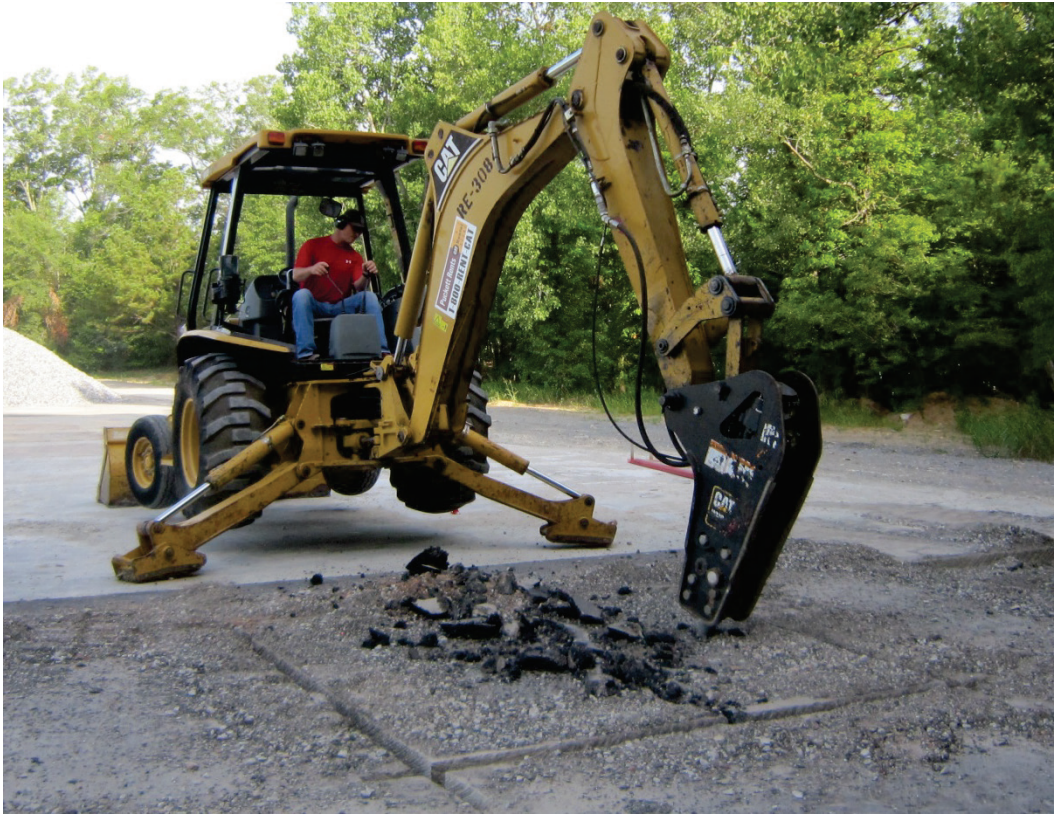
Figure 31. Breaking HMA pavement with backhoe.

The excavator, CTL, and backhoe were all evaluated for their ability to break up the thick saw-cut PCC and HMA. Moil and chisel point hammers were tested to determine if any differences in efficiency may be gained using one hammer type over the other. The excavator with the chisel hammer was evaluated on six PCC slabs, and the excavator with moil hammer was evaluated on three PCC slabs. The CTL with moil hammer was evaluated on three PCC slabs and one HMA slab. The backhoe with moil and chisel hammers were both evaluated on two PCC slabs. The breaking up of the saw-cut HMA was tested using the backhoe with the moil hammer on two slabs (Figure 31).

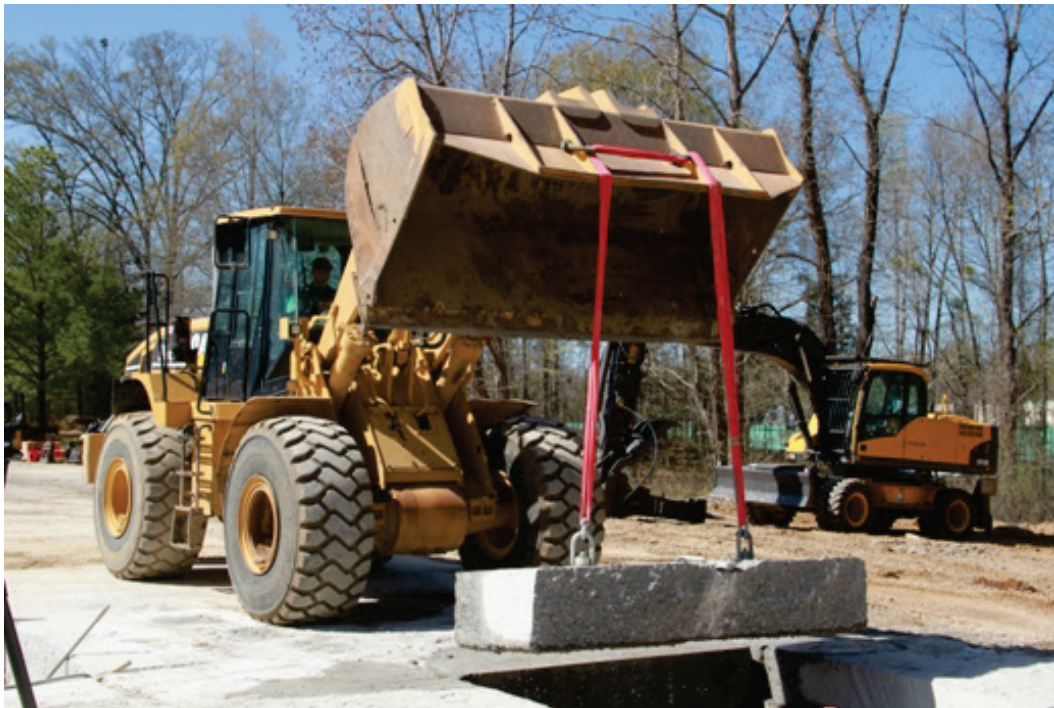
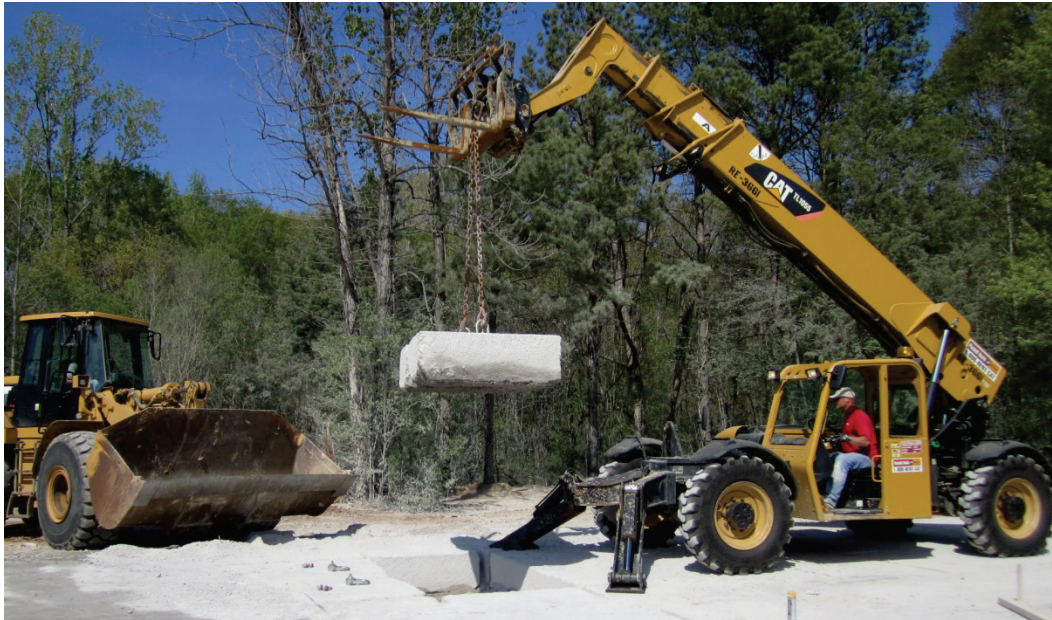
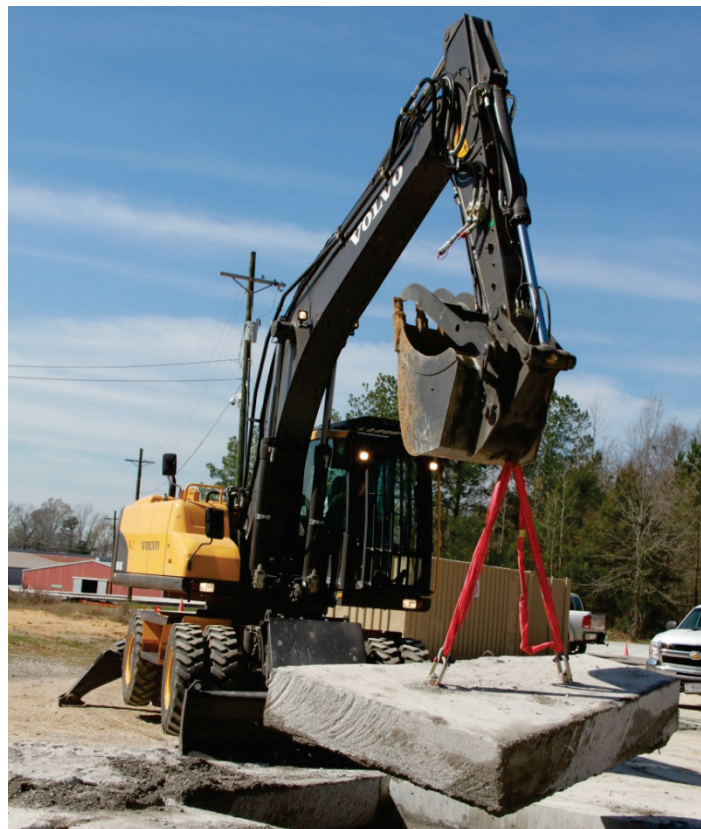
The concrete expansion anchors were used on three craters, with the front-end loader (Figure 32), CAT TL1055 extendable boom forklift (Figure 33), and excavator (Figure 34) to remove the slabs. A front-end loader was used for three half-slabs. One of the half-slabs was broken into two pieces, and the front-end loader was able to remove these two smaller pieces in one pull-out. The excavator and extendable boom forklift lifted out half-slabs using the concrete expansion anchors. Only half a slab or less was attempted with this method because of the limits of the equipment used to remove the slabs.

Figure 32. Anchor pull-out using front-end loader.

Figure 33. Removing with the forklift (CAT TL1055).

Figure 34. Removing with the excavator.
